NATIONAL PROGRAM FOR INSPECTION OF NON-FEDERAL DAMS  
NORWICH RESERVOIR DAM. (U) CORPS OF ENGINEERS WALTHAM  
MA NEW ENGLAND DIV AUG 81

NORWICH Reservoir DAM

Overview of Dam

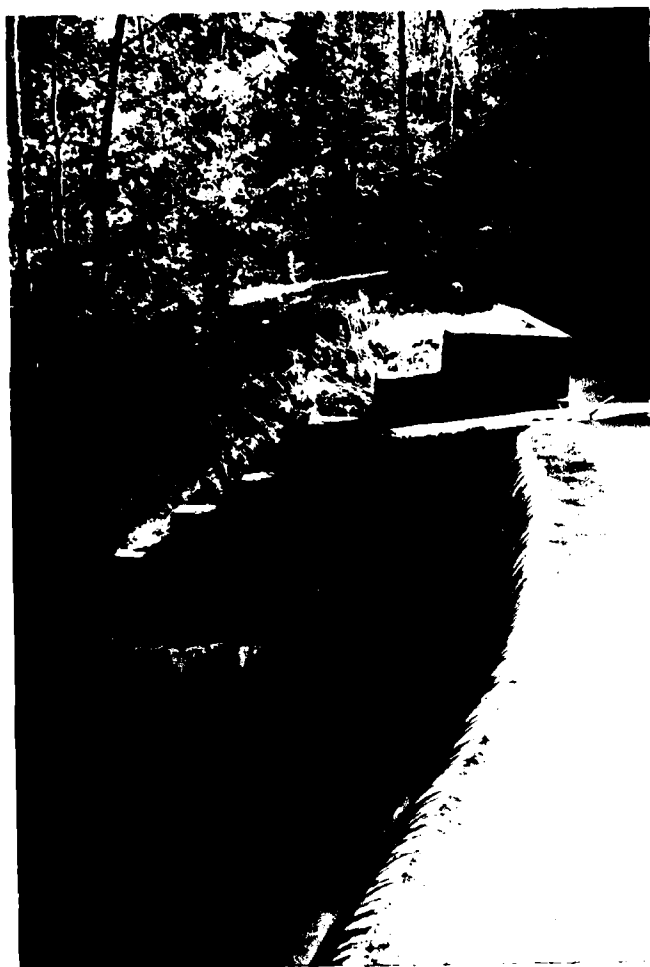
2. Crest of Spillway and Right Training Wall. Note: Thrust Wall and Embankment

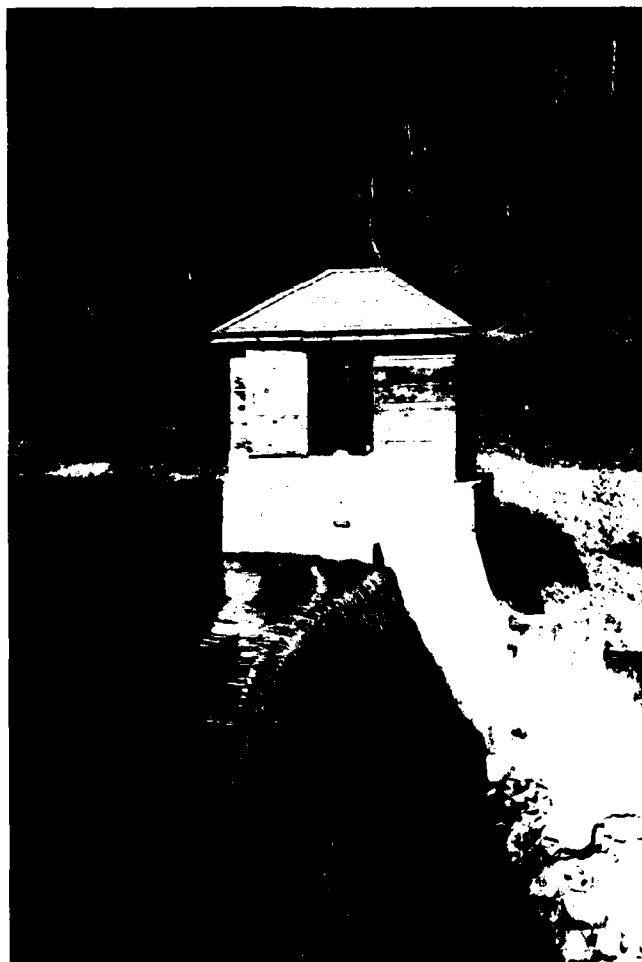
4. Crest of Spillway and Right Side of Gate House. Note: Deterioration of Concrete on Left Training Wall

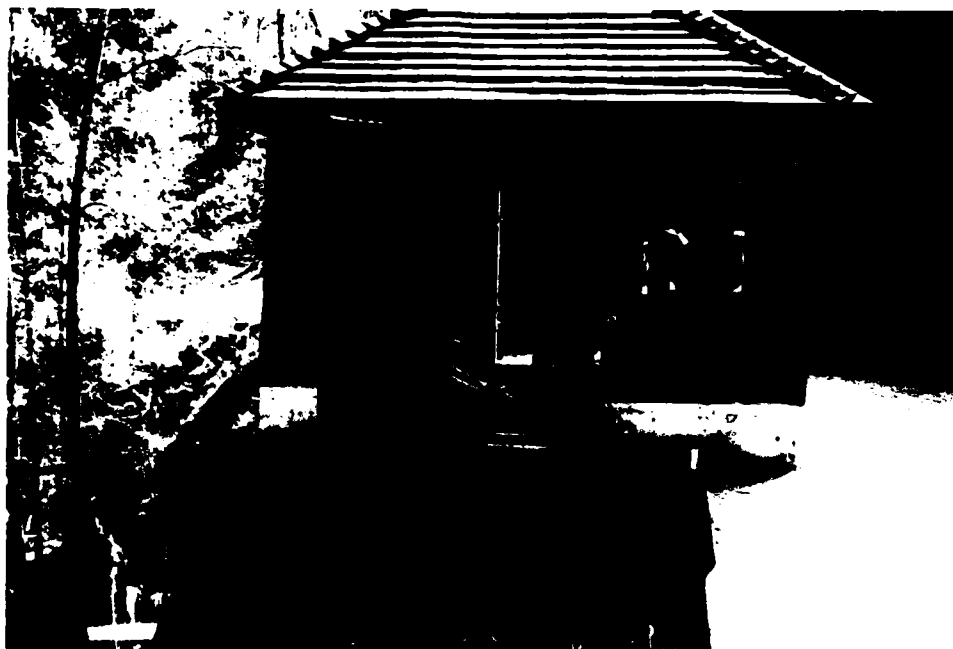
7. Gate House From Right Side

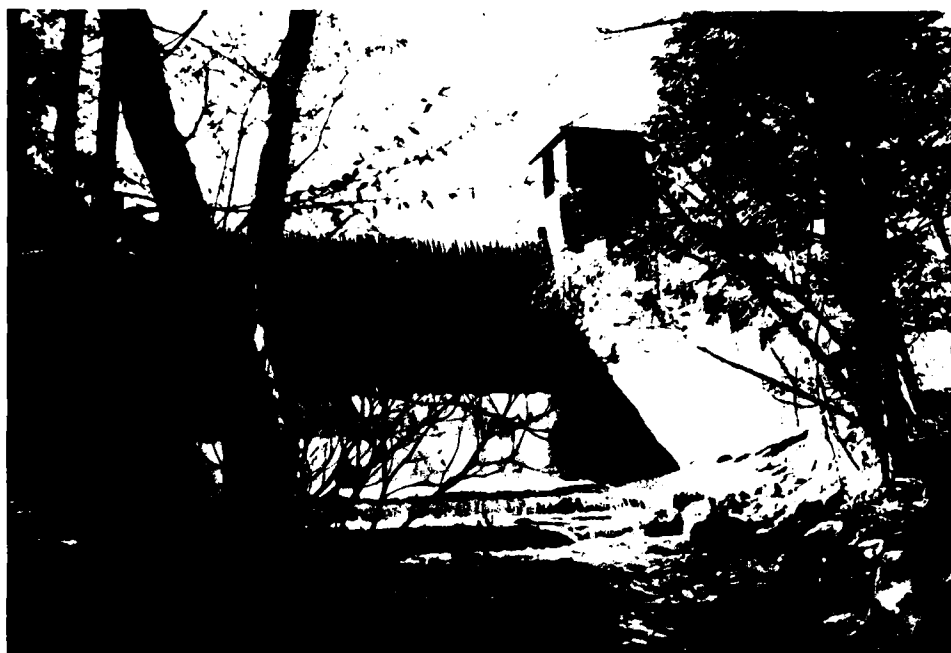
Observation of the downstream face of this structure revealed that it is stepped over its entire vertical height. Pneumatically applied mortar was observed to have spalled. The extent of spalling could not be determined due to sheet flow over the spillway. The crest is 3.5 feet below the thrust walls.

12. Downstream View of Spillway

There is evidence of spalling of the pneumatically applied mortar on the downstream face of this structure. Based upon the condition of the surrounding components, as discussed in the previous paragraphs, it is recommended that this structure be thoroughly investigated under low flow conditions.

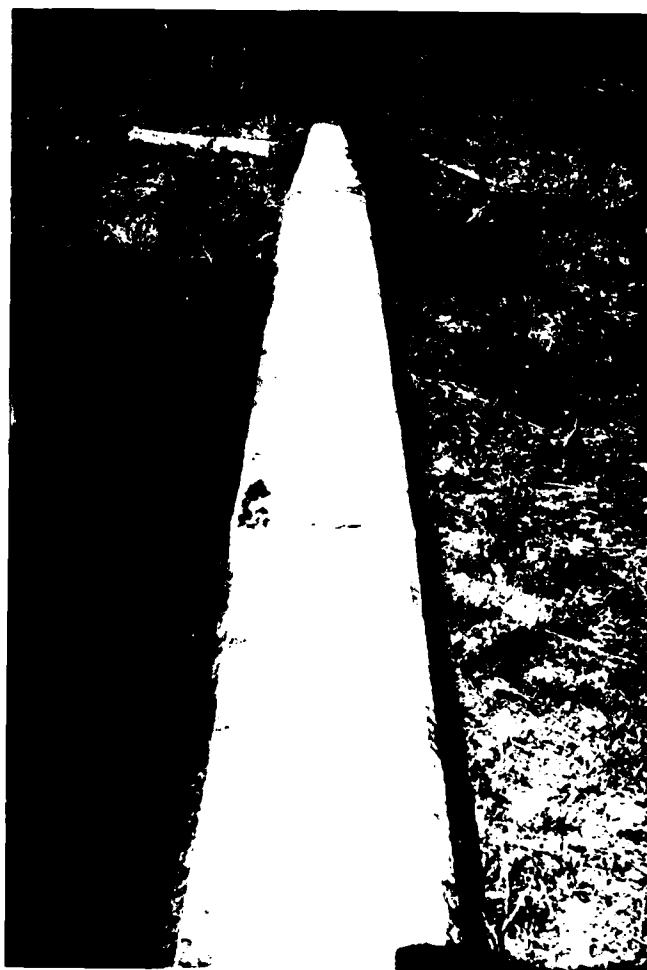
11. Left Thrust Wall From Gate House
